# The effects of tropical cyclone Vance on Exmouth

by Greg Reardon (Cyclone Testing Station, James Cook University, Townsville), Geoff Boughton (Curtin University of Technology, Perth), David Henderson and John Ginger (Cyclone Testing Station, JCU)

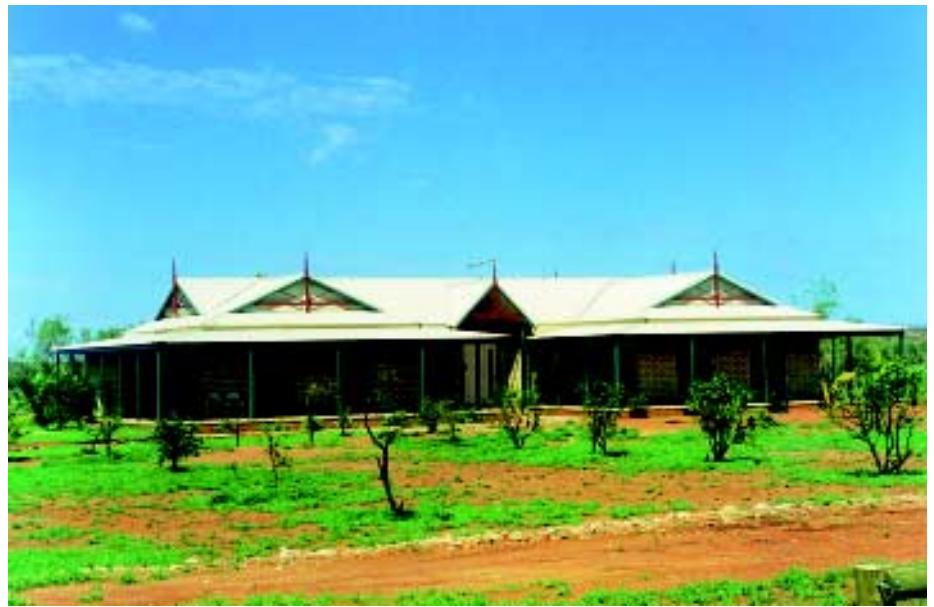
Photo 1: The majority of newer houses successfully resisted the wind forces.

The DHA houses also performed well, having virtually no major structural damage. The majority of the newer houses successfully resisted the wind forces (see Photo 1) although most had the advantage of being at the northern end of town where the wind speed is estimated to be slightly less.

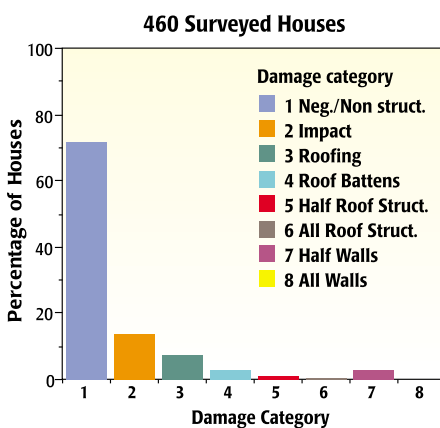
Figure 1 Distribution of damage—all houses

Figure 1 shows a graph of the distribution of damage for all houses surveyed.

Figure 1 shows that about 70% of housing had only minor damage and a further 15% was damaged by debris. Thus only about 15% of houses had structural damage, including loss of roofing. These statistics were unexpected for a town that had been hit by winds of up to 250 km/h. After cyclone Tracy, a category 4 event, Darwin had much higher percentages of serious damage (Lester and Reardon, 1976). Even the damage potential listed in Table 1 for category 4 wind speeds predicts greater damage than shown in Figure 1.

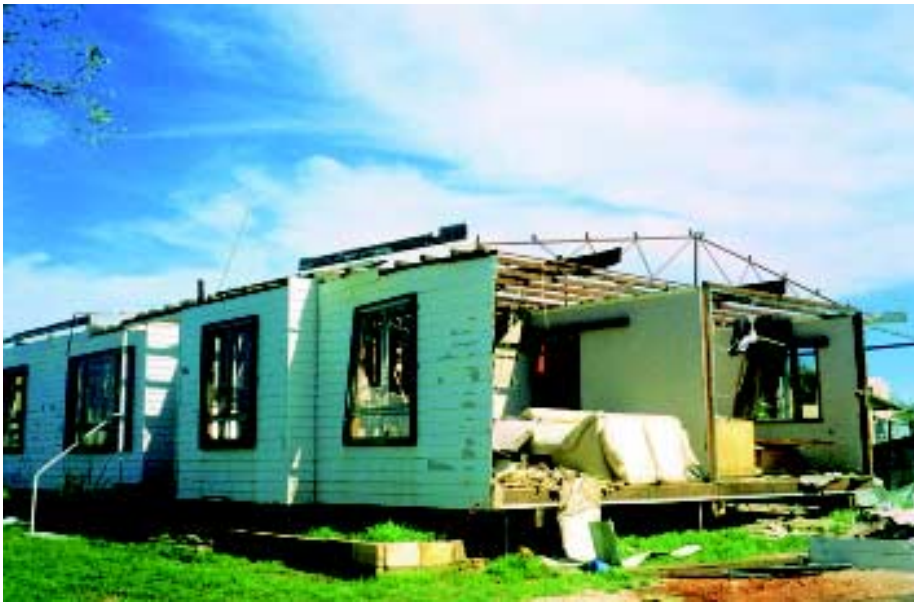
Photo 2: Transportable houses put in the poorest performance of any housing group.

The transportable houses put in the poorest performance of any of the groups. This type had generally been built in two sections in Perth, transported to the site and joined together. They lost roof structure and sometimes walls. Most of them were of older construction, with timber framed walls and timber or steel roof trusses. Photo 2 shows one that had lost its roof and walls. At least one new steel framed transportable house on the southern outskirts of town lost its entire roof structure (Photo 3) due to inadequate fixing of the trusses.

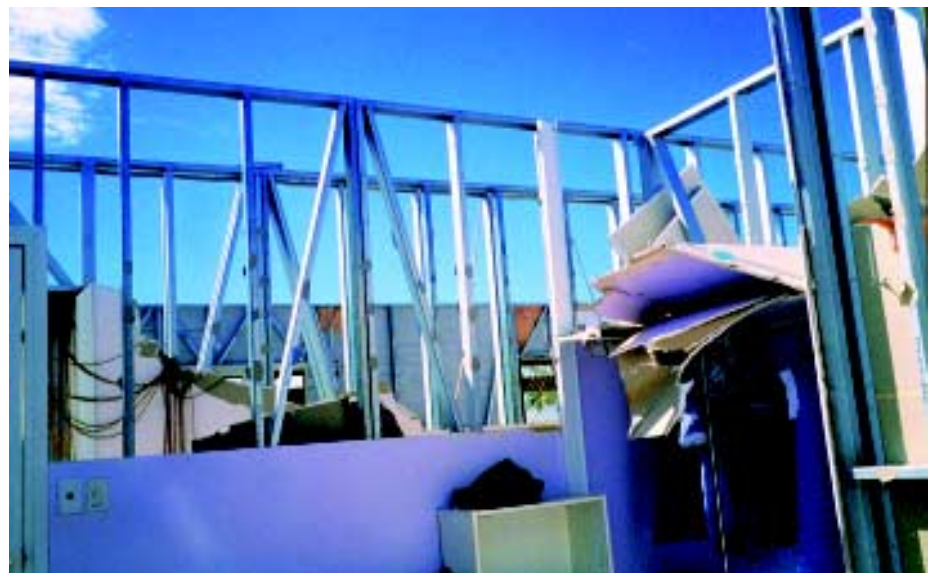
Photo 3: This new transportable home lost its entire roof structure due to inadequate fixing of trusses.

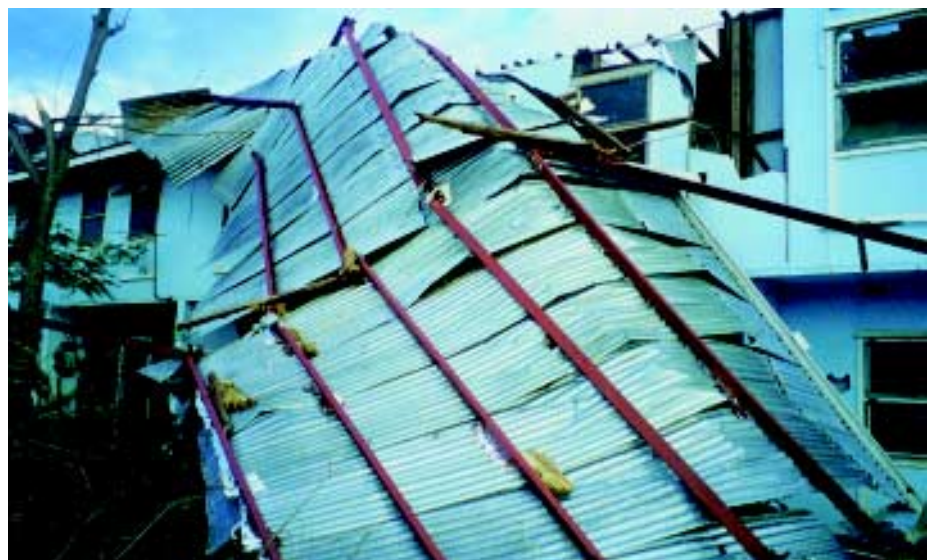
Four out of five blocks of flats lost their entire roof structure from the leeward slope in similar fashion. Photo 4 shows one of the roof slopes. In each case the leeward slope

peeled off in one piece, initiated by failure near the ridge. Failure was a classic case of inadequate tie down from roof to foundations. The plane of the roof structure had been well designed with robust members bolted together and an adequate bracing system. But the tie down to internal party walls was not sufficient.

Photo 4: On this block of flats, the leeward roof slope peeled off in one piece, initiated by failure near the ridge.

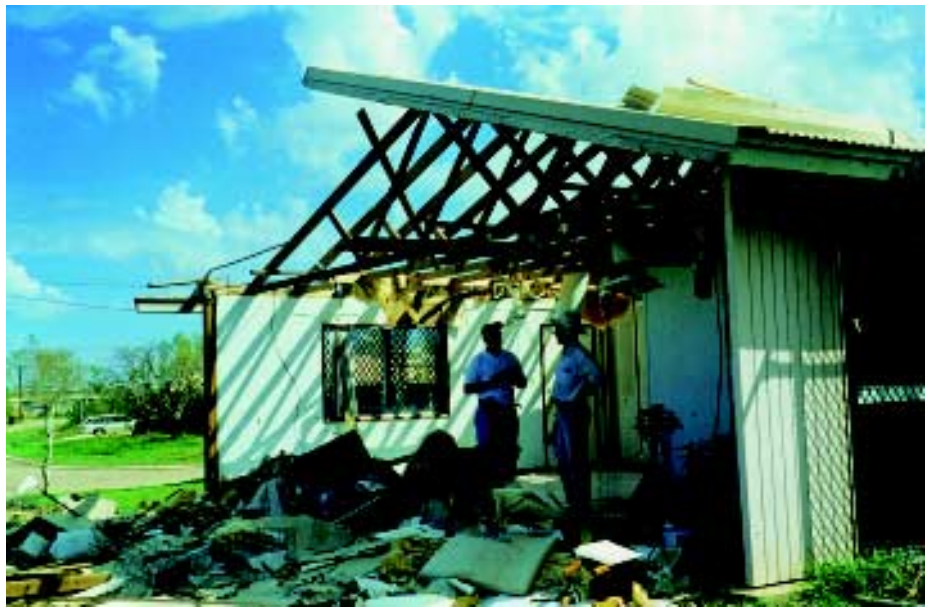
water entry and other damage. Doors on some of the US kit homes flew open when the striker plate tore out of the door jamb. This pressurised the interior of the houses and, in a number of instances, caused failure of the end wall. *Photo 5* shows such a failure.

*Photo 5: Failure of the end wall due to interior pressurisation.*

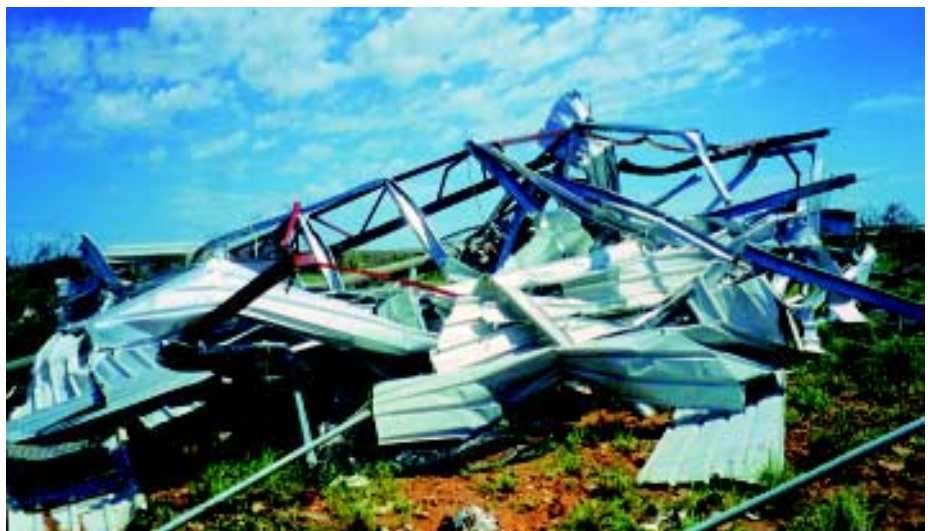
Most of the industrial buildings were fairly new. They usually had open webbed steel trusses on posts spaced two to three metres apart. Most resisted the wind forces, but sometimes lost some flashing or one or two sheets of cladding. There was one spectacular exception, where the columns pulled out of the ground, the building became flying debris, hit two others and finally wrapped around a light pole (*Photo 6*). A couple of older industrial buildings were stripped of all roofing. There were reports of this cladding from the industrial area flying to the adjacent residential area and causing missile damage to housing.

*Photo 6: This entire building became flying debris, coming to rest wrapped around a light pole.*
