Role of building codes and construction standards in windstorm disaster mitigation

David Henderson and John Ginger from James Cook University, examine the role of Australia's building code and construction standards in a number of windstorm disaster mitigation situations.

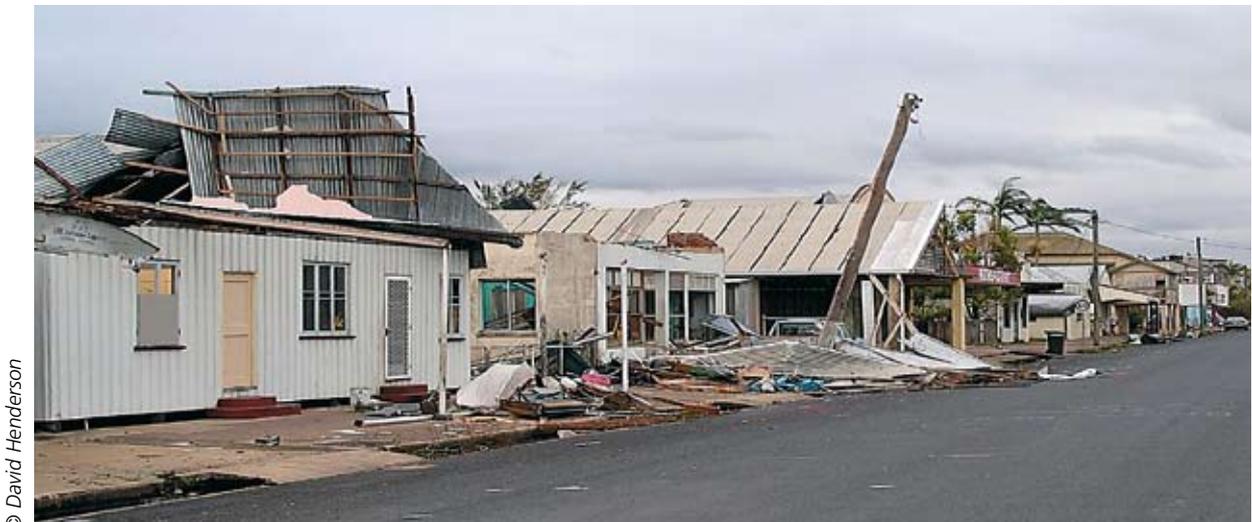
Tropical Cyclone Larry crossed the North Queensland coast in the early morning of Monday 20th March 2006, causing severe damage to buildings, agriculture, and infrastructure for power, communications and services in the Innisfail region (Figure 1). Wind damage extended well into the Atherton Tablelands and flooding was reported in the Innisfail area, the Tablelands and into the Gulf country.

Figure 1: Damage in Mourilyan from TC Larry.
