Flood warning and awareness at Blandswood Peel Forest

South Canterbury, New Zealand

by Peter Kingsbury, Hazard Analyst,
Canterbury Regional Council,
Christchurch, New Zealand

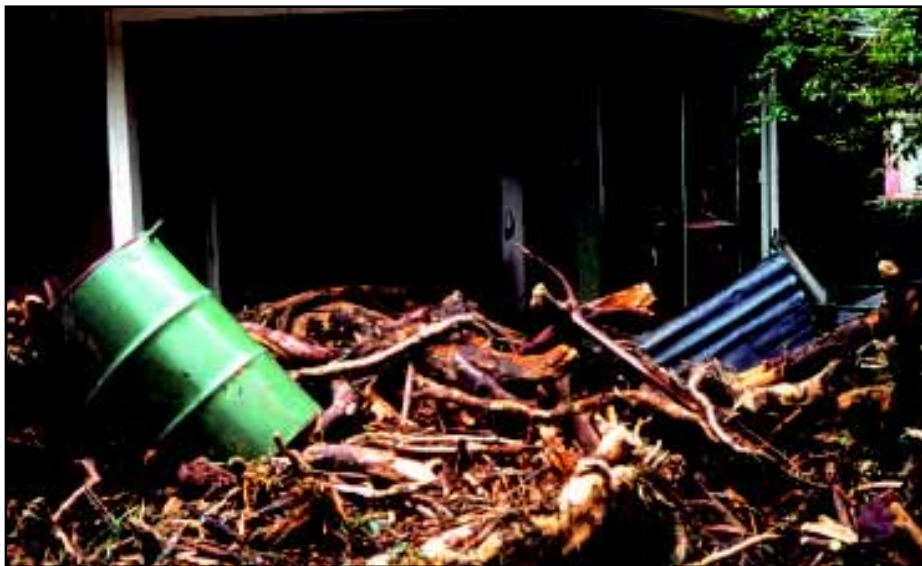
Figure 1: Debris piled up against home, 1975

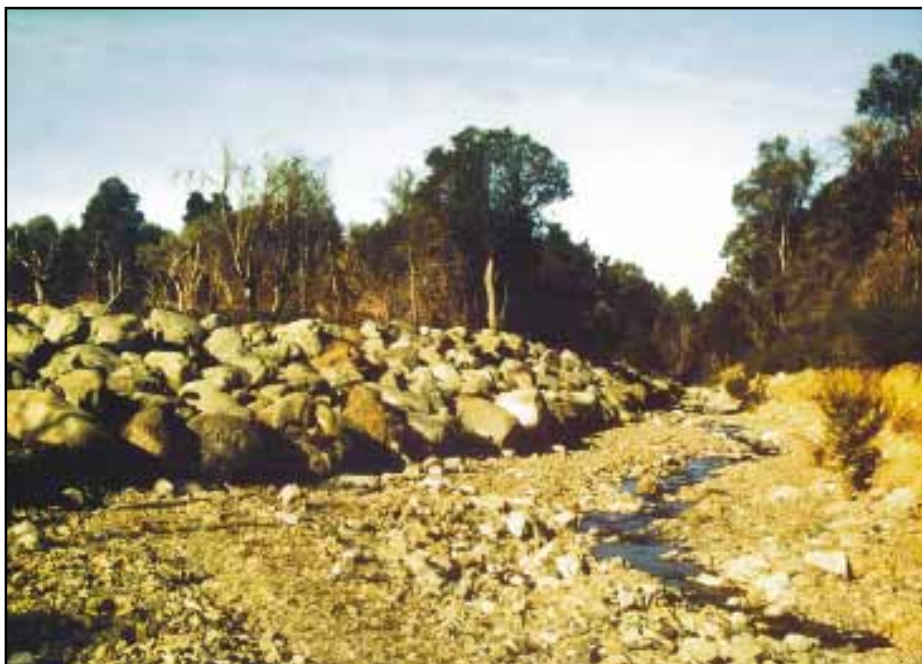
Figure 2(a): Kowhai Stream in 1985 showing the recently completed protective works.

protection works (*figures 2a & 2b*). Since 1975 the Kowhai Stream has aggraded by 2 to 3 metres.

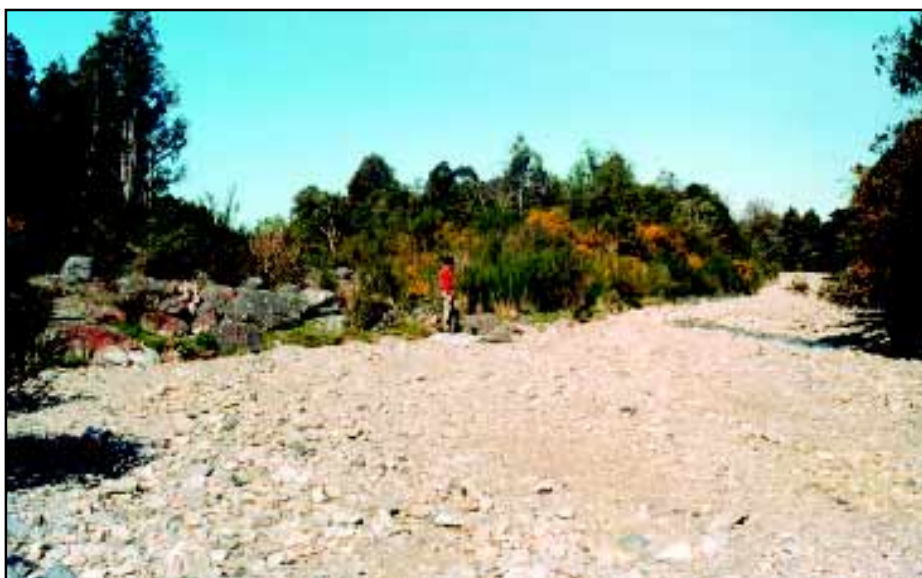
Figure 2(b): The same view of the Kowhai Stream in 1996 showing the significant increase in stream bed-level.

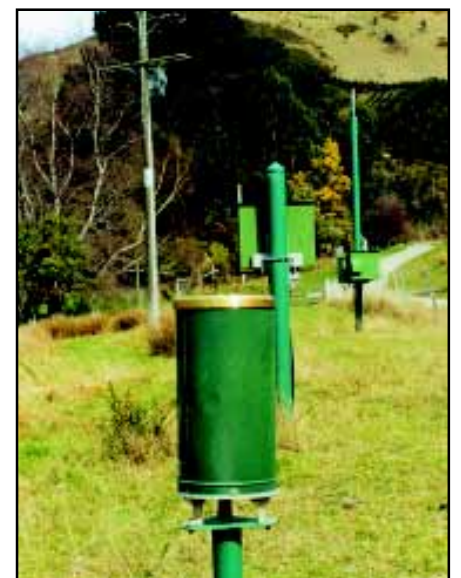
Figure 3: Telemetered rain gauge site at Blandswood

The flood warning system is based on antecedent rainfall, long-range weather forecasting and real-time weather surveillance. A telemetered rain gauge has been installed at Blandswood providing a daily rainfall record (*figure 3*).

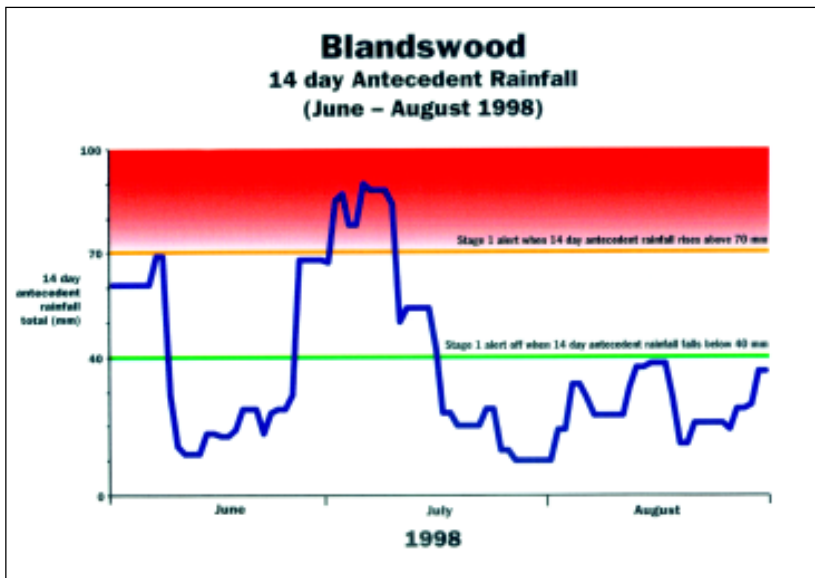
Figure 4: Antecedent rainfall record (June - August 1998)

A two stage warning system is in place. A Stage 1 alert occurs when a total of 70 mm of rain has fallen over the preceding 14 days (*figure 4*). When this critical level is reached the flood danger signs are changed from *LOW flood danger* to *HIGH flood danger* (*figure 5*). At this time people within the flood hazard zone may be advised directly of the flood alert state.

The local Civil Defence officer is advised and people evacuated from the flood hazard zone. Immediate evacuation is essential as devastating flood surges will take only minutes to reach Blandswood. The Stage 1 alert remains in place until the antecedent rainfall falls below 40 mm (*figure 4*).

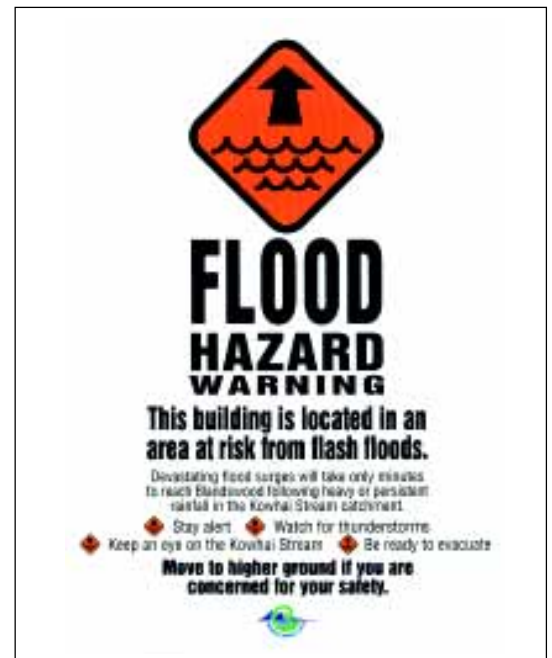
Figure 6: Flood warning notice displayed in homes in flood hazard zone

A flood hazard warning notice (*figure 6*) was sent to each property owner in the flood hazard zone. Property owners were encouraged to display the notice in a prominent place in their dwelling.

An 'international' symbol (indicating rising water) has been used deliberately on all signs and documents to link each source of information and provide a common theme (Figures 5, 6 & 7).

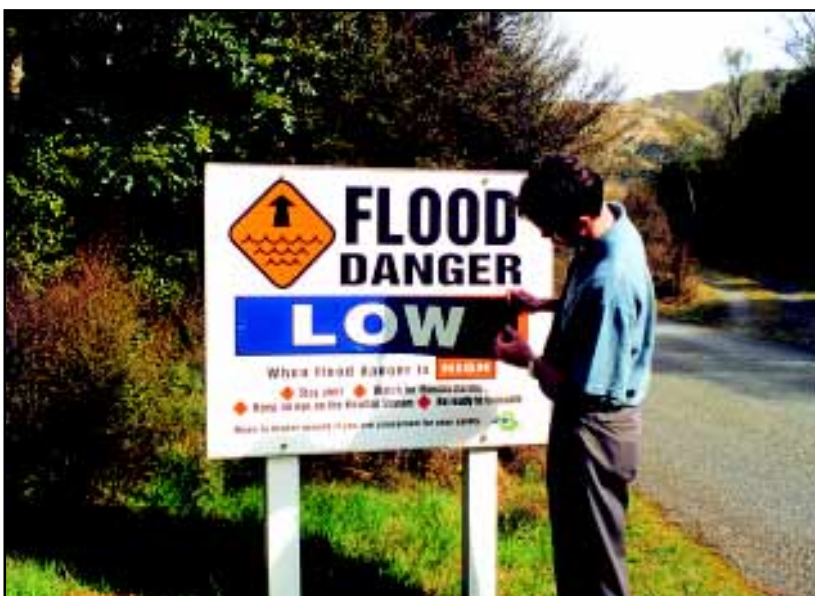
Figure 5: Changing the flood danger sign to 'HIGH' as the antecedent rainfall threshold (70 mm) is reached.

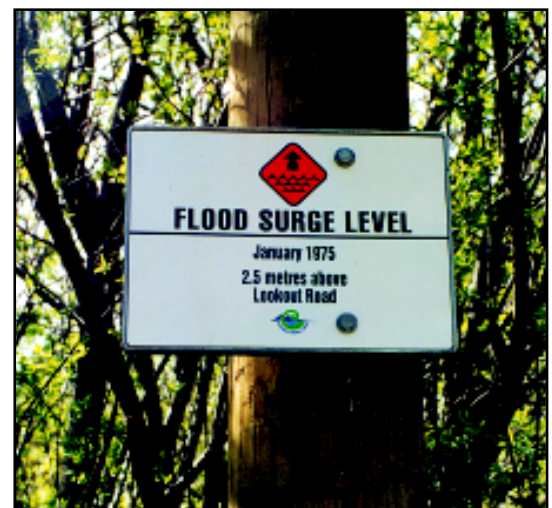
Figure 7: 1975 flood surge level

A sign indicating the 1975 flood level at Lookout Road is displayed in Blandswood (figure 7). Flood surges, estimated at up to 3.5 metres high, swept through Lower Blandswood in 1975.
