Landslide risk in Cairns

by Marion Michael-Leiba, Ken Granger and Greg Scott, Cities Project, Australian Geological Survey Organisation

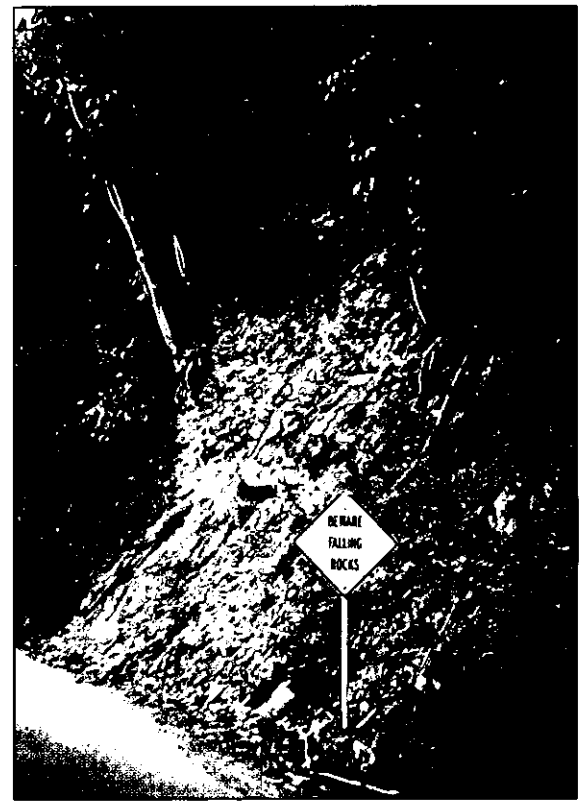
above: This landslide on Barron Gorge Road was triggered by rain brought by Tropical Cyclone Justin in March 1997.
