Landslips – a moving story (a Municipality’s perspective)

by Lex Ritchie & Glenn Hunt, Asset Management Department, Shire of Yarra Ranges, Victoria, Australia

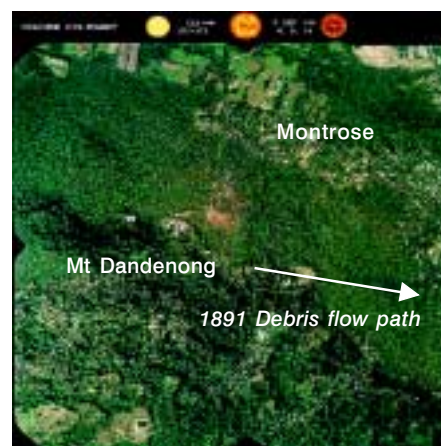
Figure 1: the Montrose landslide 1891 – 30,000 cubic metres of earth and rock moved down the slope at approximately 40km per hour.

A landslide occurred in 1891 on the north western slopes of Mt. Dandenong.

To give an indication of the severity of this landslide, the Thredbo Tragedy in July 1997 involved the displacement of 2,000 cubic metres of liquefied soil, whereas this event involved the movement of 30,000 cubic metres of earth and rock—damage was recorded over at least 1.4 kilometres and the flow was said to have reached speeds of up to 40 kilometres per hour.

It is believed that the major contributing factor to the 1891 landslip was the heavy rainfall that continued unabated over a three day period from about midnight on Friday 10th July until Sunday 12th July 1891.

During the 1891 landslip relatively minor damage was recorded. The damage included the destruction of a house and some outbuildings in the path of the debris. Two horses were carried some 600 metres downslope and killed, two people were caught in the debris flow, narrowly escaping death, with one being buried in the debris.

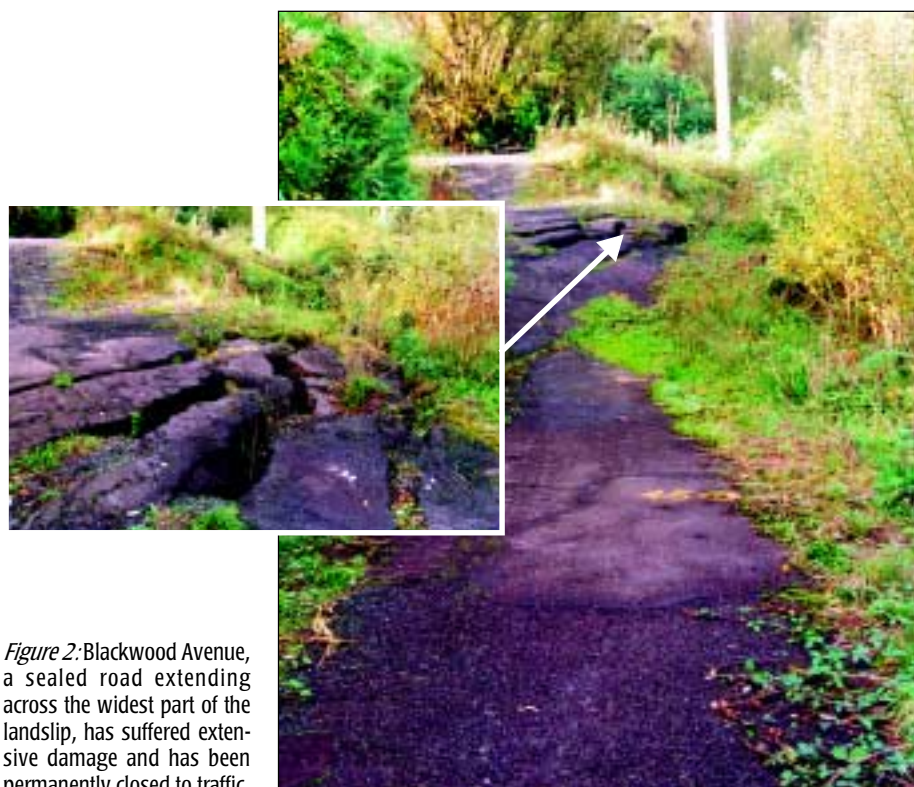
Figure 2: Blackwood Avenue, a sealed road extending across the widest part of the landslip, has suffered extensive damage and has been permanently closed to traffic.

In October 1992 an active landslip in Blackwood Avenue, Warburton moved significantly causing the evacuation of houses in the immediate area and the permanent closure of the road.

The Blackwood Avenue landslip lies on the north bank of the Yarra River at Warburton. The toe of the landslip is at the edge of the river. Cumulative movements up to about 1.5 metres have been measured on the Blackwood Avenue landslip in the last seven years. Concern has been expressed that this landslip may fail catastrophically, blocking the river, and this could lead to flooding of the Warburton area.

The landslip covers approximately 6 hectares. It is irregular in shape and has a maximum length of about 320 metres and a maximum width of about 230 metres.

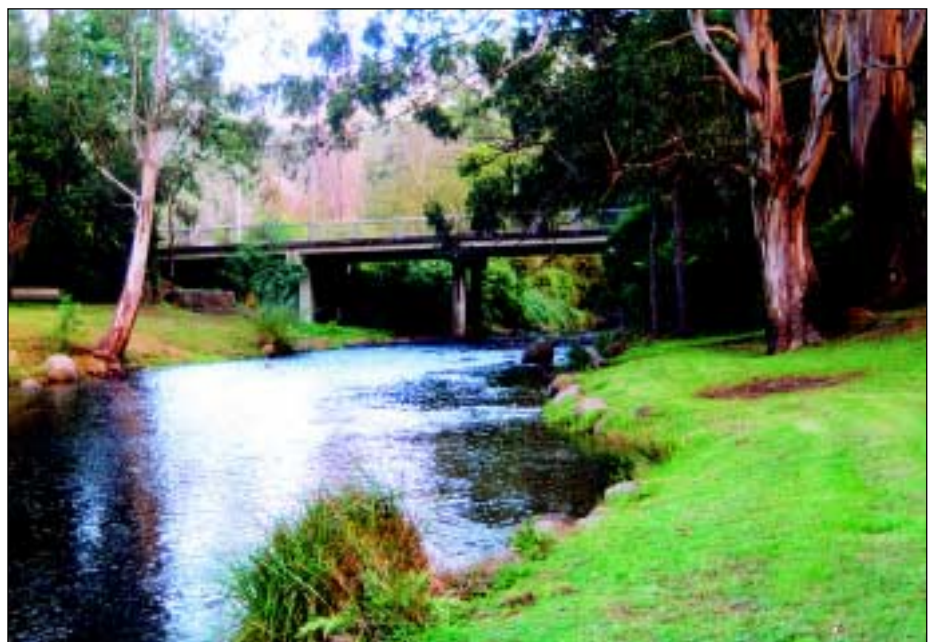
Figure 3: The Blackwood Avenue landslip lies on the north bank of the Yarra River at Warburton. The toe of the landslide is at the edge of the river. In the unlikely event of a total blockage of the river, infrastructure such as the bridge spanning the Yarra River could be affected.

No evidence has been found to suggest the landslide may have blocked the Yarra River in the geological past, let alone in more recent times. The available evidence indicates the landslide is 'slowly shuffling' along, most likely in response to heavy rainfall and that substantial movements causing the river to totally block are unlikely to occur. Irrespective, given the narrowness of the river, the uncertainties regarding the behaviour of any landslide and the events that could take place in a major storm/flood event, the consequences of the landslide blocking the river need to be considered.

In the very unlikely event of a total blockage of the river, the resulting landslide dam is likely to be made up of loose debris, which would erode quickly, particularly if over topped by the river. If the unexpected happens and the dam is not rapidly eroded, flooding will occur. This will, in turn, primarily affect infrastructure, such as the bridge spanning the Yarra River, which carries the main Highway through the township (*Figure 3*). This would result in the isolation of services such as the hospital and the volunteer fire brigade and cause flooding of a nearby caravan park. Should this occur, the consequences are considered to be manageable.
